SOUTHEAST ASIA ACTIVITY REPORT

SELECTED TRANSPORTATION AND INFILTRATION COMPENDIUM

15 SEPTEMBER 1967

NPIC/R-174/67 SEPTEMBER 1967

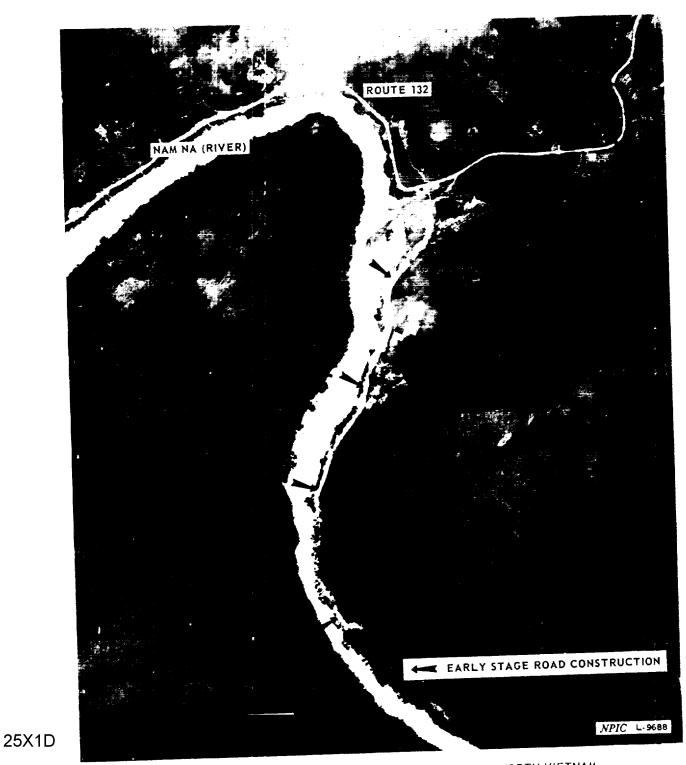
A new road is under construction in the area of North Vietnam Routes 132 and 604 near the China border (Figures 1 and 2). The new road will connect the two Routes and shorten the north-south supply route by nine nautical miles. On unusually heavy traffic (approximately 88 vehicles observed in cloud-free areas) was noted on the current route through Phong Tho to Lai Chau. Present early-stage construction extends south from Route 132 at 22-35- N 103-16- E and north from Route connected. A river crossing will be needed over the Nam So (River) near sections were located on south side of Nam So.

FIGURE 1. ROAD CONSTRUCTION, ROUTES 132/604 AREA, NORTH VIETNAM

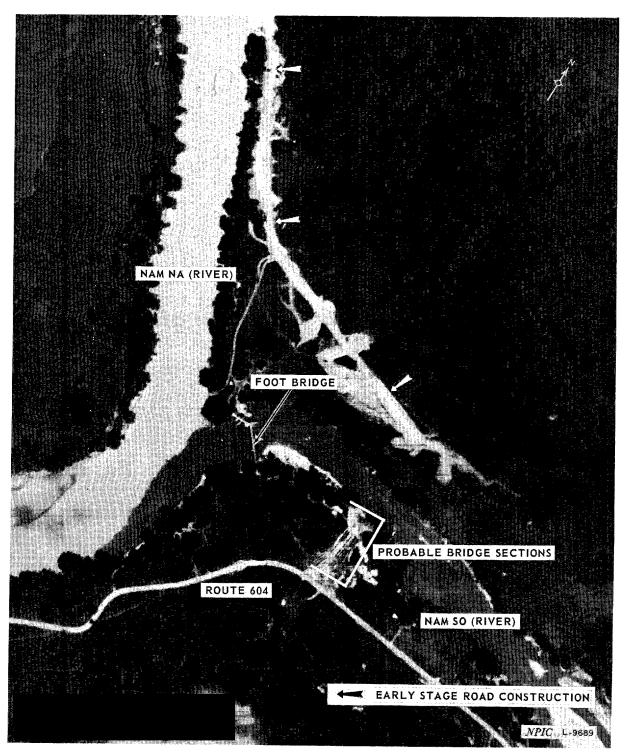
25X1D FIGURE 2. ROAD CONSTRUCTION, ROUTES 132/604 AREA, NORTH VIETNAM

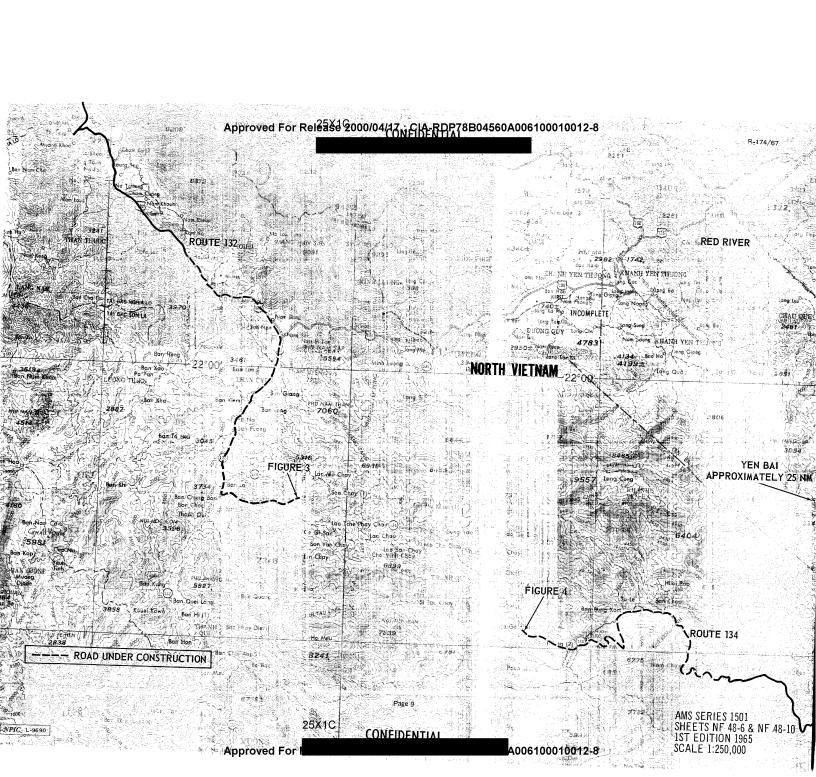
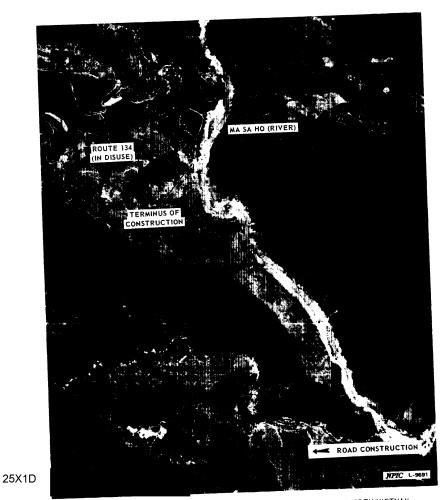
2. Continued Road Construction, Routes 132/134 Area, North Vietnam 25X1D Continuing road construction and route realignment to connect Route 134 to Route 132 are observed on a mission of ing roads are overgrown and in disuse and only portions of them are being 25X1D incorporated into the new northwest-southeast alignment. Construction generally following the alignment of Route 132 is observed from 22-06N 103-50E (previous terminus of construction as reported in Summary No 39, Item 2) south to 21-53N 1.03-52E _____, and then east along the 25X1D north bank of the Nam Kim (River) to the present terminus at 21-52N (Figure 3). Construction and realignment west along 25X1D Route 134 presently terminates at 21-45N 104-10E leaving a 15-nm gap between the construction termini (Figure 4). At least 12 trucks/construction vehicles and three new construction camps are observed along the new northern construction segment. 25X1D NPIC Cable Cite 1784, DTG 182248Z, Sep 67, Ser F00468

FIGURE 3. CONTINUED ROAD CONSTRUCTION, ROUTES 132/134 AREA, NORTH VIETNAM

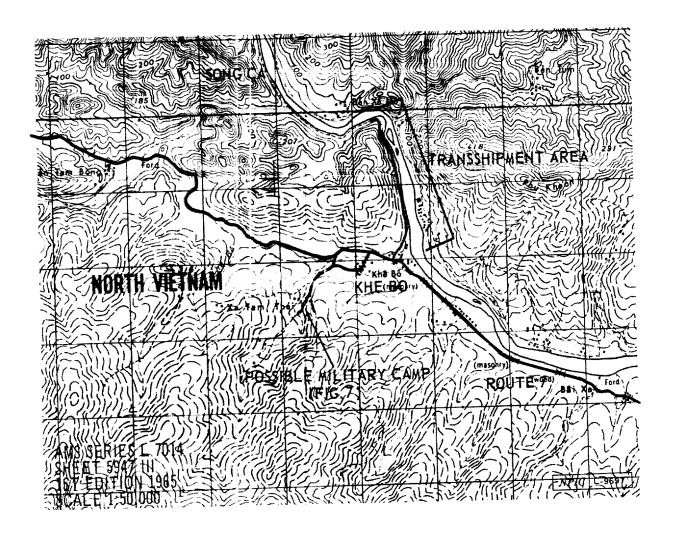
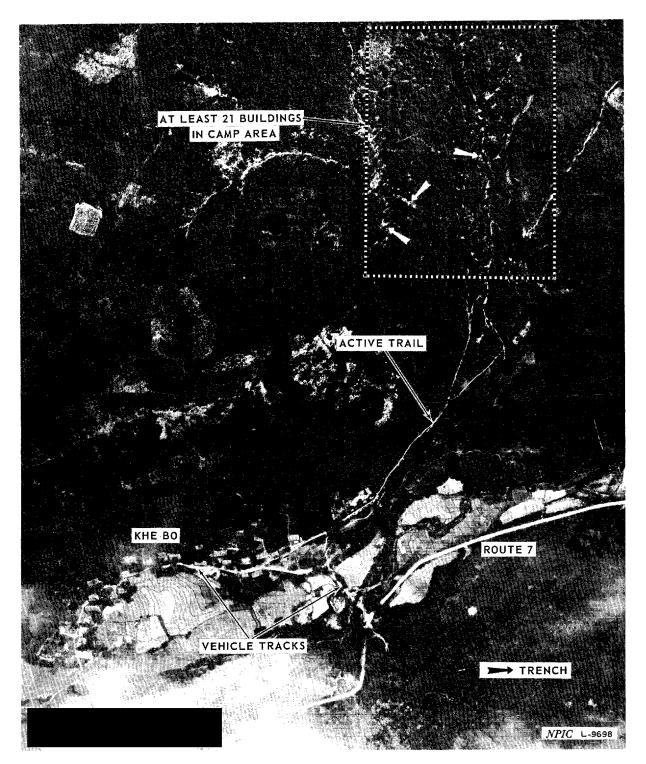
A possible military camp is identified approximately 1,000 yards southwest of Khe Bo on Route 7 at 19-09- N 104-40 (Figure 7). Heavy ground scarring, three personnel trenches, and at least 21 buildings are located under a heavy tree canopy. An active trail network connects the area with Route 7. The camp could be used in support of vehicular traffic on Route 7 and/or in support of the nearby active transshipment point on the Song Ca (River) between and

FIGURE 7. POSSIBLE MILITARY CAMP, KHE BO, NORTH VIETNAM

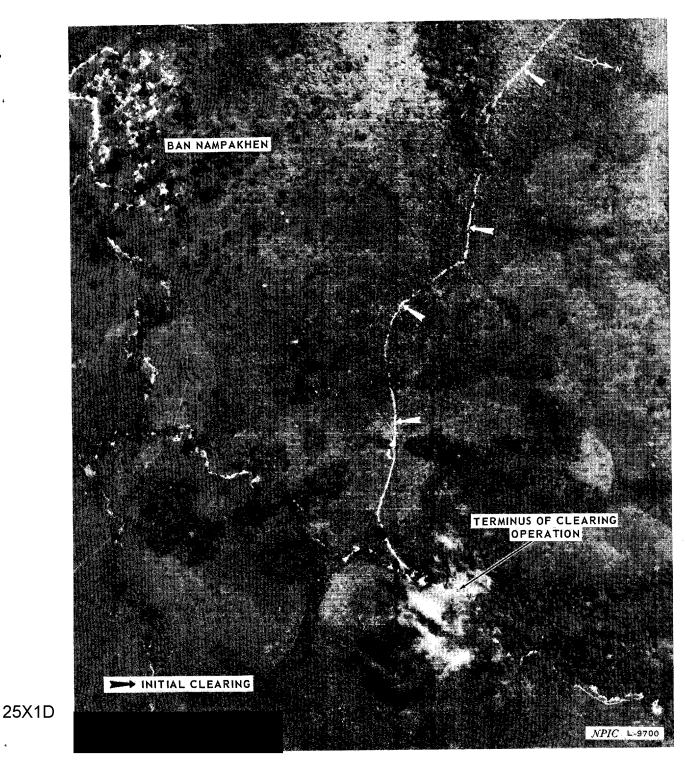
25X1D 25X1D Initial clearing operations for a new by-pass are observed southeast of the junction of Routes 911 and 912 (Figure 8). As observed in cloud-free areas, the clearing extends east from 17-01-18 N 105-58-18 E to a terminus at 17-02-18 N 106-01-18 When completed, the road will by-pass a heavily cratered segment of Route 911 just south of Route 912 junction.

FIGURE 8. PROBABLE BY-PASS ROAD UNDER CONSTRUCTION, ROUTES 911/912 AREA, LAOS

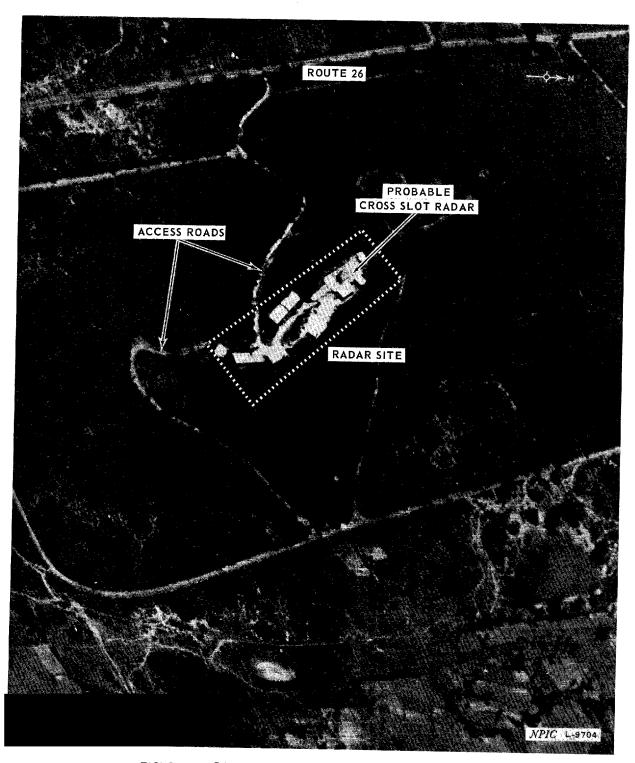
A new early warning radar site is observed approximately 12 nm west of Phnom Penh at 11-34-11 N 104-41 E , 0.4 nm south of Ph Leak Cheung. This is the first radar site in Cambodia to be photographically confirmed by NPIC. The site consists of one probable CROSS SLOT radar mounted atop a control building, seven additional support buildings, and access roads to Route 26 (Figure 10).

FIGURE 10. RADAR SITE, PH LEAK CHEUNG, CAMBODIA
